# Inspection Report

3914 S 115th St  
Tukwila, WA 98168

<b>Date:</b> 8/1/2006	<b>Time:</b> 10:30 AM	<b>Report ID:</b> 08012006 - Queirolo
<b>Property:</b> 3914 S 115th St Tukwila, WA 98168	<b>Customer:</b> Chad Queirolo	<b>Real Estate Professional:</b> Kristen Meyer Keller Williams

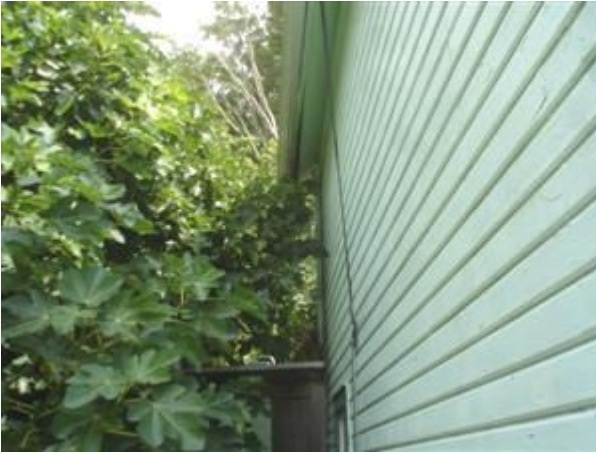
1.6 Picture 1

There is vegetation in contact with the structure. All vegetation should be trimmed at least 6-12" away from the structure to eliminate a common avenue for pest infestation and damage to the exterior structure material.

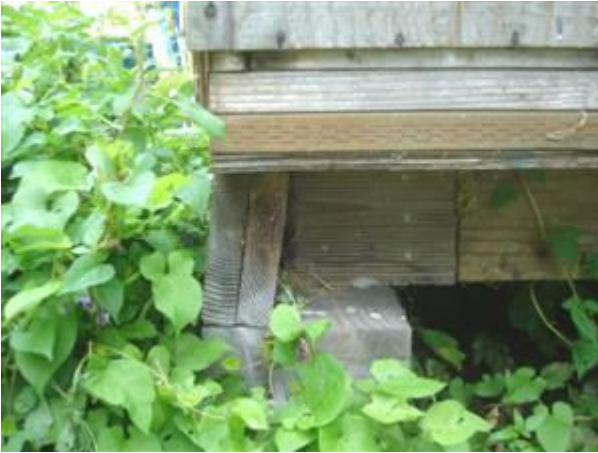
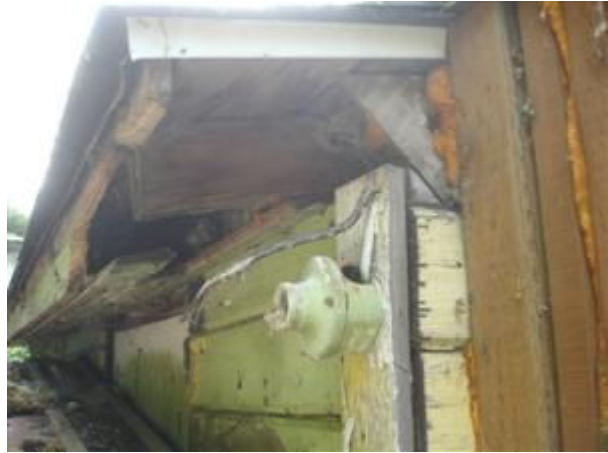
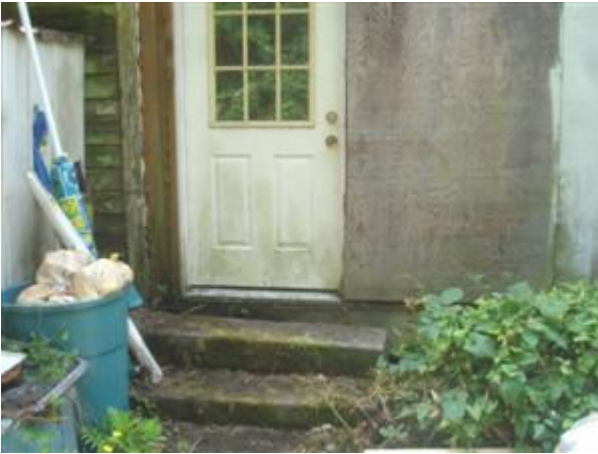
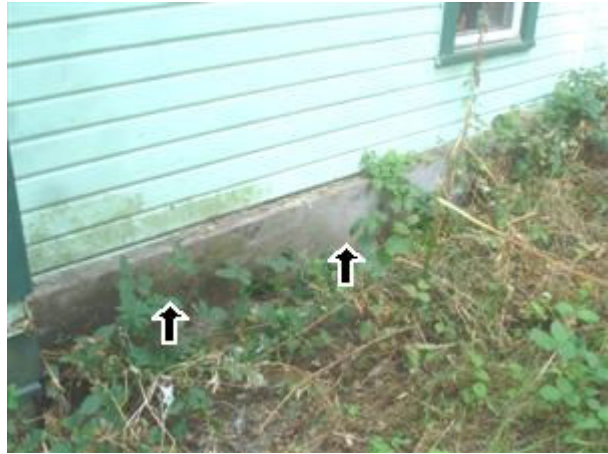
There appear to be 3 additions that have been installed and constructed onto the north side of the structure at some time in the past. The inspector noted numerous improper issues pertaining to these additions:

1. Improper materials being used as exterior siding members
2. Earth to wood contact at numerous locations
3. Structural damage visible at the exterior, underside of the NW structure and numerous improper issues visible in the crawlspace area (rot, insect damage, improper framing methods, etc.)
4. Improper roofing techniques (evidence of leaks)
5. Mold in the laundry area
6. Bathroom and laundry room floor damage/rot
7. Lack of proper earth support beneath the foundation walls
8. Structural posts in the crawlspace that are not bearing properly on footings

It is highly recommended that a licensed contractor be contacted to provide full evaluation of the north side additions as a measure to determine the cost effectiveness of repairing or replacing this area of the structure. It is of this inspector's opinion that removal of all of the additions is warranted at this time. Please see the additional comments and recommendations made in the body of this Summary Report.

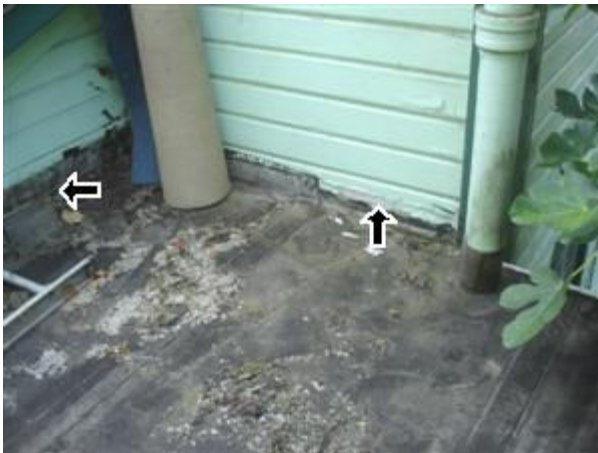
4.4 Picture 1

The inspector noted lack of proper flashing between the lower north and south side roof surfaces and the upper walls of the home. These areas will be in need of being properly flashed as a measure to prevent moisture intrusion/roof leaks.

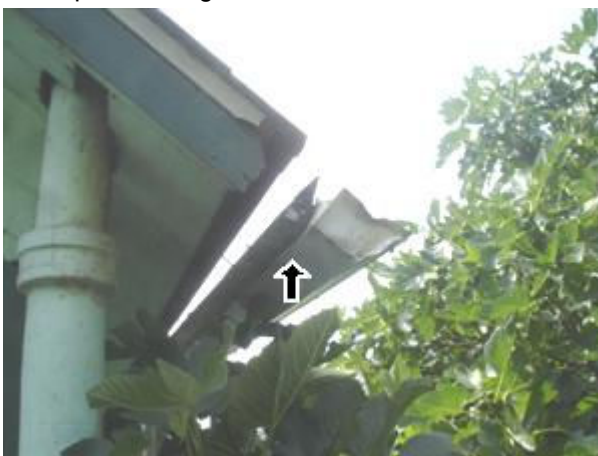
4.5 Picture 1

1. The upper east and west side gutters are loose and pulling away from the structure. Advise providing secure installation as a measure to properly divert all roof water away from the home.
2. There are lack of gutters and downspouts at the north side addition. Recommend installing downspouts and gutters at the north side of the structure.

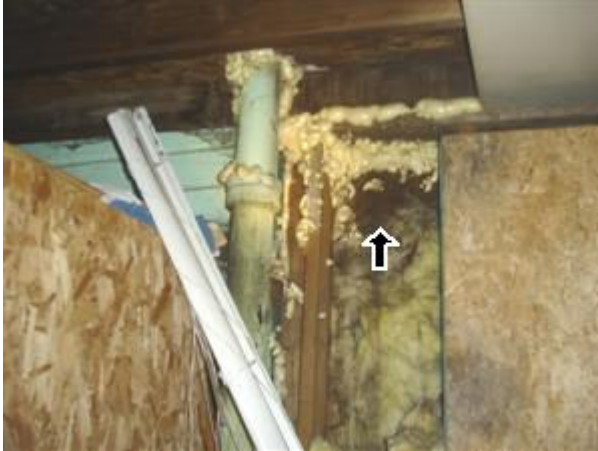
4.7 Picture 1

Moisture stains are visible on the interior of the structure between the existing home and north side addition. This is located near the main sewer vent pipe. Advise contacting a licensed roofing contractor to provide further evaluation and repairs as deemed necessary.

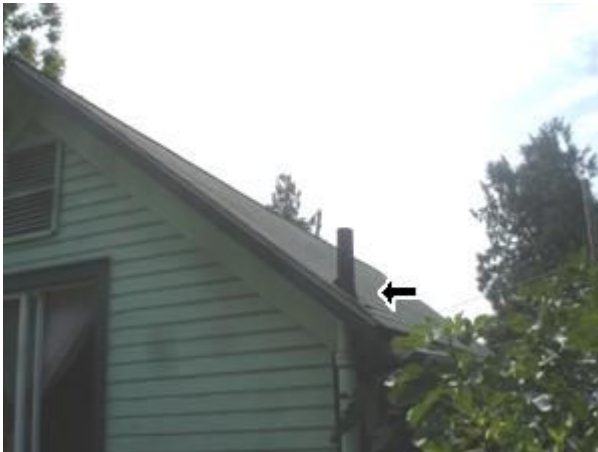
4.8 Picture 1

There is a dip in the upper west side sloped roof surface. This appears to be due to structural settlement. Recommend contacting a licensed contractor to provide further evaluation as the installation of additional support members may be needed.

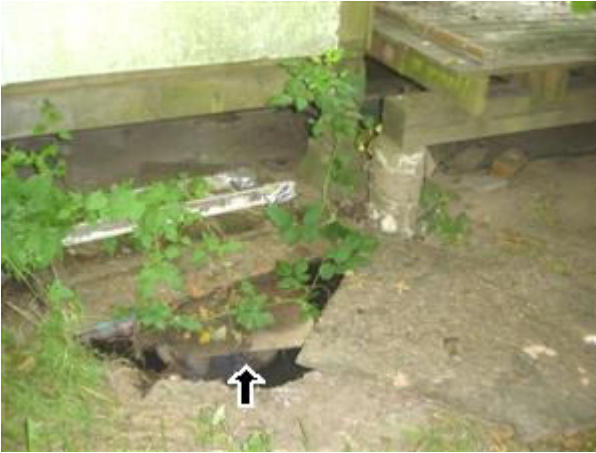
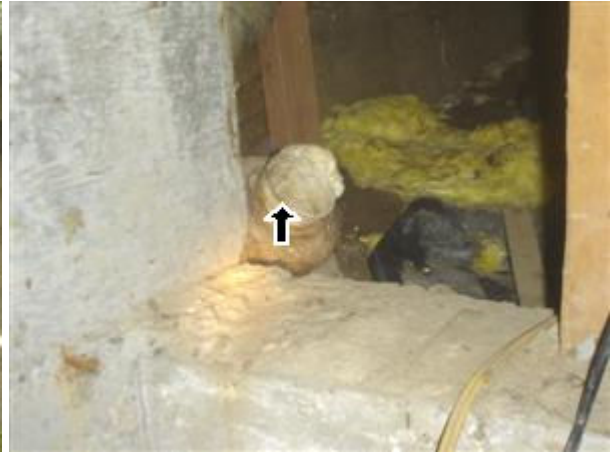
There is an open well at the west side of the structure that appears to be the septic tank (Picture 1). Standing water and a strong sewer-type odor was present at this location. In addition, the main clean-out opening in the waste pipe in the crawlspace is currently open (Picture 2). It is highly recommended that a professional septic tank expert be contacted to provide further evaluation of the plumbing waste system for the structure. This to include an evaluation of the tank, drainfield and all related components. Repair as deemed necessary.

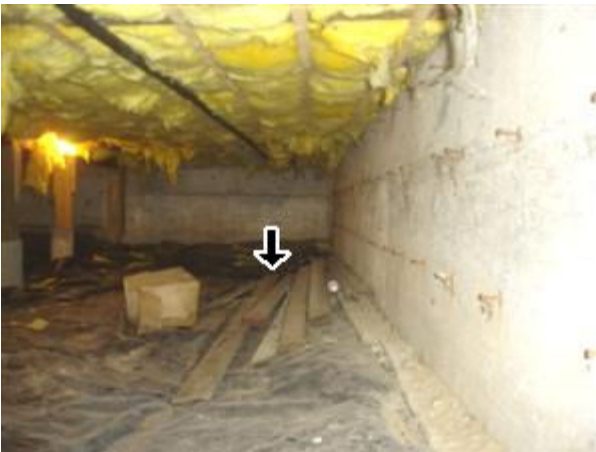
6.4 Picture 1

There is wood debris in the crawlspace that is in need of being removed. This is a food source for insects.

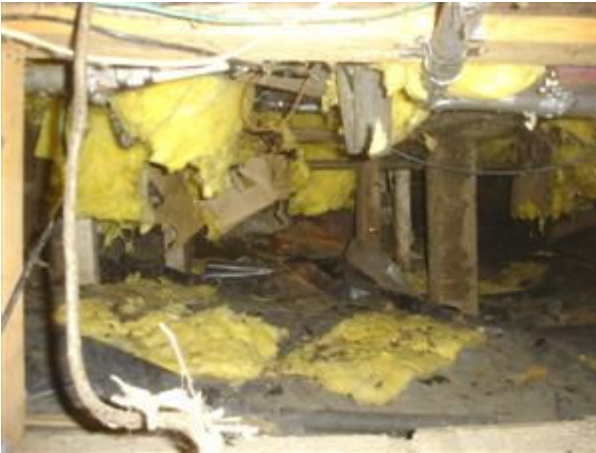
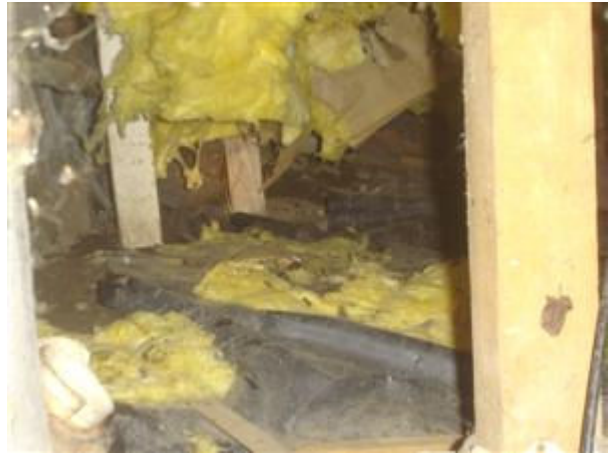
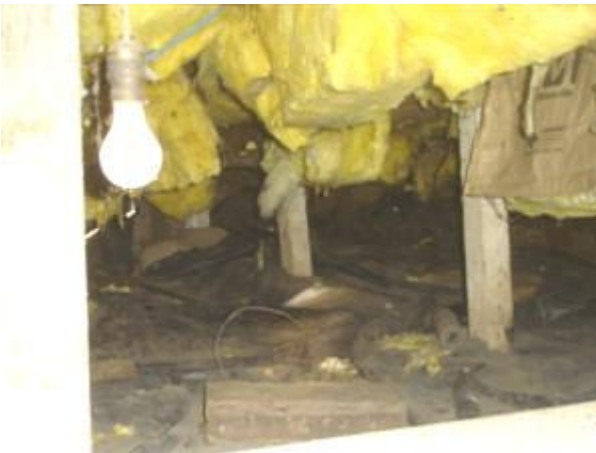
There are a number of locations beneath the structure where the floor insulation is loose and/or damaged. Recommend contacting a qualified expert to provide repair or replacement.

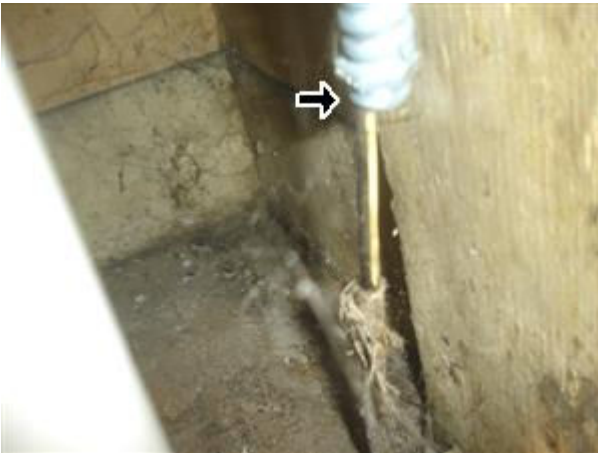
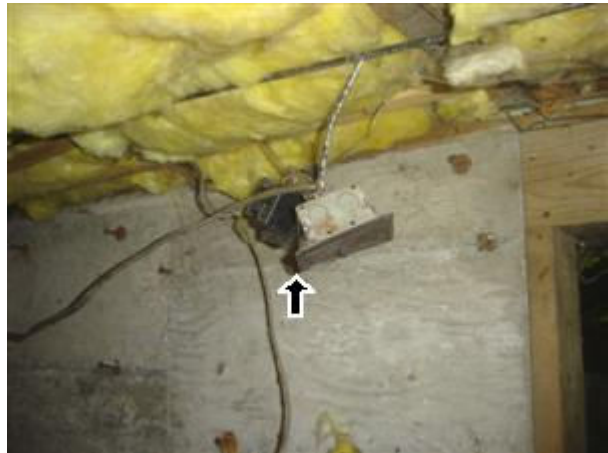
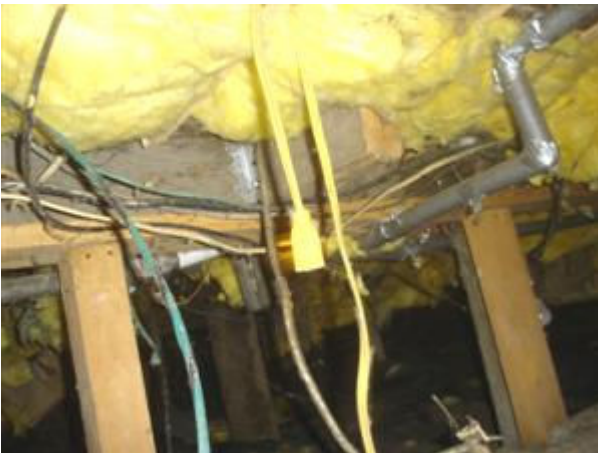
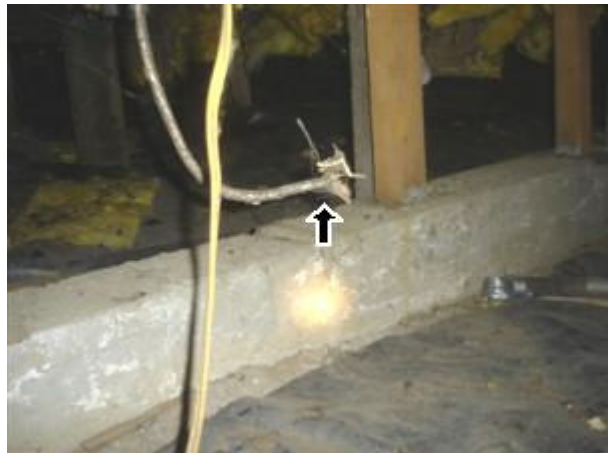
1. The conduit over the water heater wiring is improperly sized. The metal edge of the conduit is improperly in contact with electrical wires. (Picture 1)
  2. The wires to the clothes dryer outlet are improperly exposed.
  3. Numerous improper and hazardous electrical issues exist in the crawlspace area. (Pictures 2-4)
- It is recommended that a licensed electrician be contacted to provide further evaluation of the above mentioned issues and that remedial work as deemed necessary be performed.

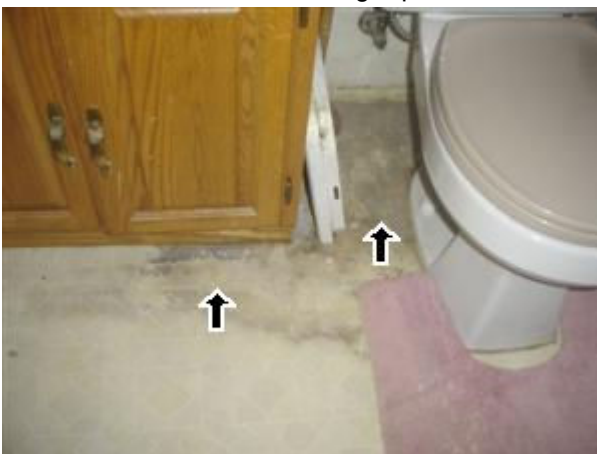
13.0 Picture 1

Rot is present in the bathroom floor at the base of the toilet. Moisture stains are visible in the vinyl at the base of the vanity and toilet. Recommend contacting a licensed contractor to provide an invasive evaluation of this area including replacement of all damaged wood members.

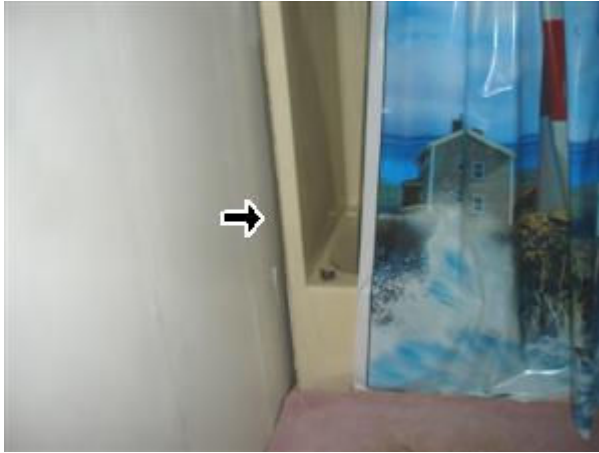
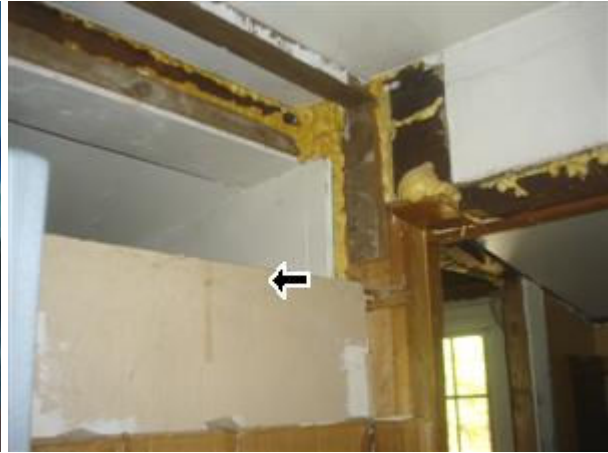
The bathroom tub/shower unit is not properly installed. The unit is not sealed or installed tight against the sidewalls. Recommend contacting a licensed contractor to provide proper installation.

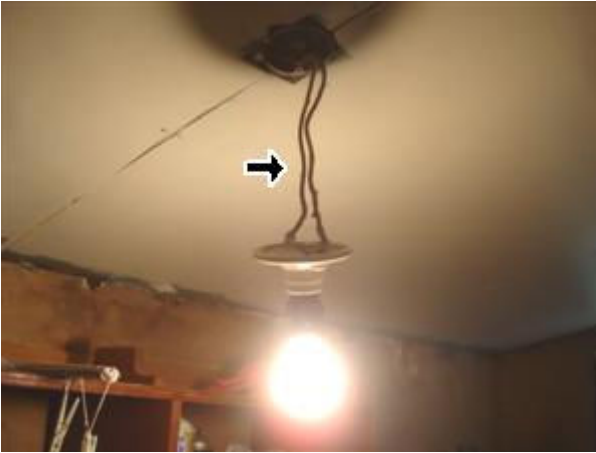
15.6 Picture 1

The light fixture in the laundry room is currently suspended by electrical wires. In addition, the switch is defective. Recommend replacement.

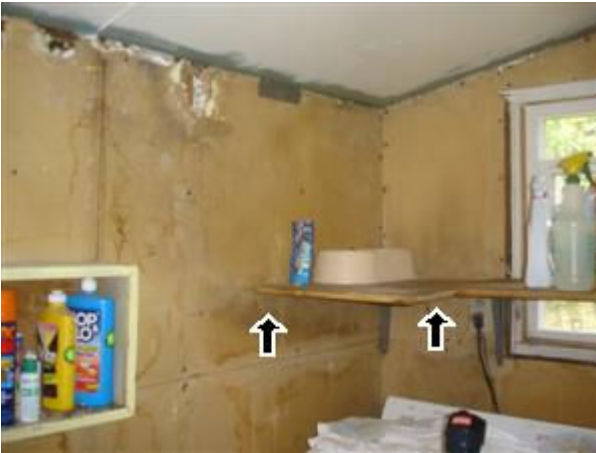
15.8 Picture 1

What appears to be mold is visible on the walls and ceilings in the laundry room. Mold testing is outside the scope of this inspection. Please note that some molds can be health hazardous. It is recommended that mold testing be performed in this area as a safety measure.
